SAFETY ALERT!

No. SMS/A/23

Collision of a Basket 14 EVO

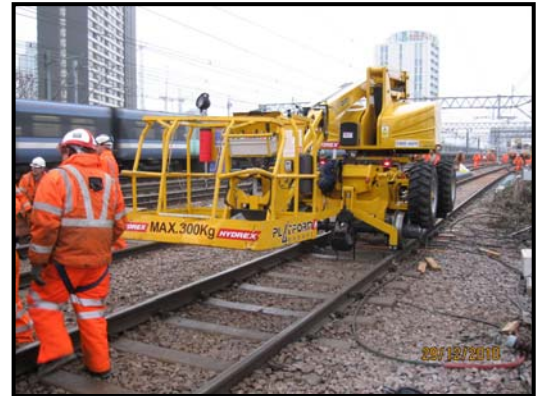
Risk: There is a serious risk of collision when operating Basket 14 EVO machines close to other OTP due to the time delay of the brakes operating and moving the direction lever in a particular direction, will result in the machine moving in opposite direction depending which end the basket is over.

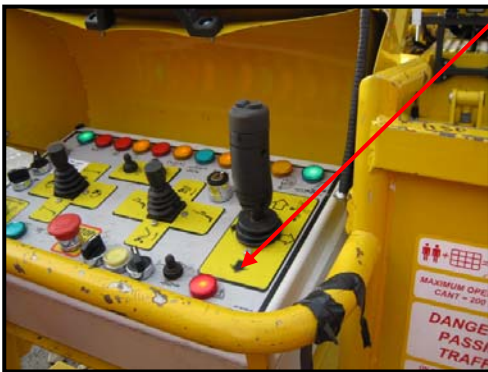
When operating the MEWP with the basket over the float end axle, moving the lever towards the black arrow symbol will move the machine in the forward direction, the rail navigation lights will show white at the basket end. Whereas when the basket is over the fixed end, moving the lever towards the black arrow will move the machine in the opposite direction.

Due to disorientation, it is easy to move in the opposite direction than planned. Therefore, when moving the machine, it is recommended to 'feather' the lever to ensure the movement is made at slow speed to check the direction is as expected.

Remember: - The rail navigation lights at the operating end will always indicate the direction of travel so it is another check that can be made if in doubt.
