No: IGS 252

Infrastructure Group Safety Bulletin

Accident at Hither Green Depot.

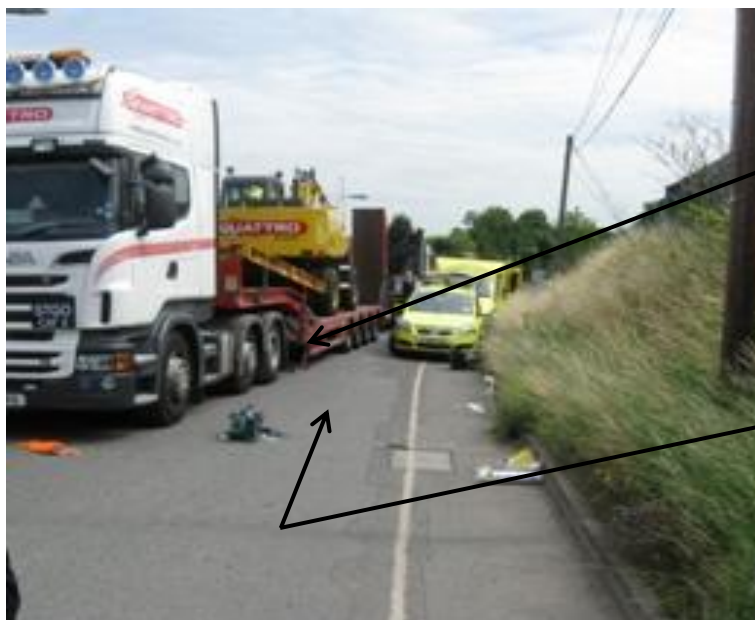
Fig 1:- Site of the Accident

The injured person was working at this point.

This is the scene after the injured person has been removed to Hospital. This is also the view the driver would have had as he left the depot approaching the stationary low loader.

From marks at the scene, it is believed the front offside wheel mounted the kerb, onto a grass verge.

It is believed the rear wheel failed to follow the front and was constrained by the kerb. It is believed the rear of the moving lorry crushed the injured person against his lorry.

- 1. All employees and contractors are to be briefed on the circumstances of this accident and reminded of the risks in and around depots and access roads from moving vehicles.**
- 2. All employees must consider and implement a safe system of work when working on the off side of a vehicle on the public highway.**
- 3. When using Road Rail Vehicles, all employees must consider the arrangements in place for delivery/collection of the Road Rail Vehicle.**

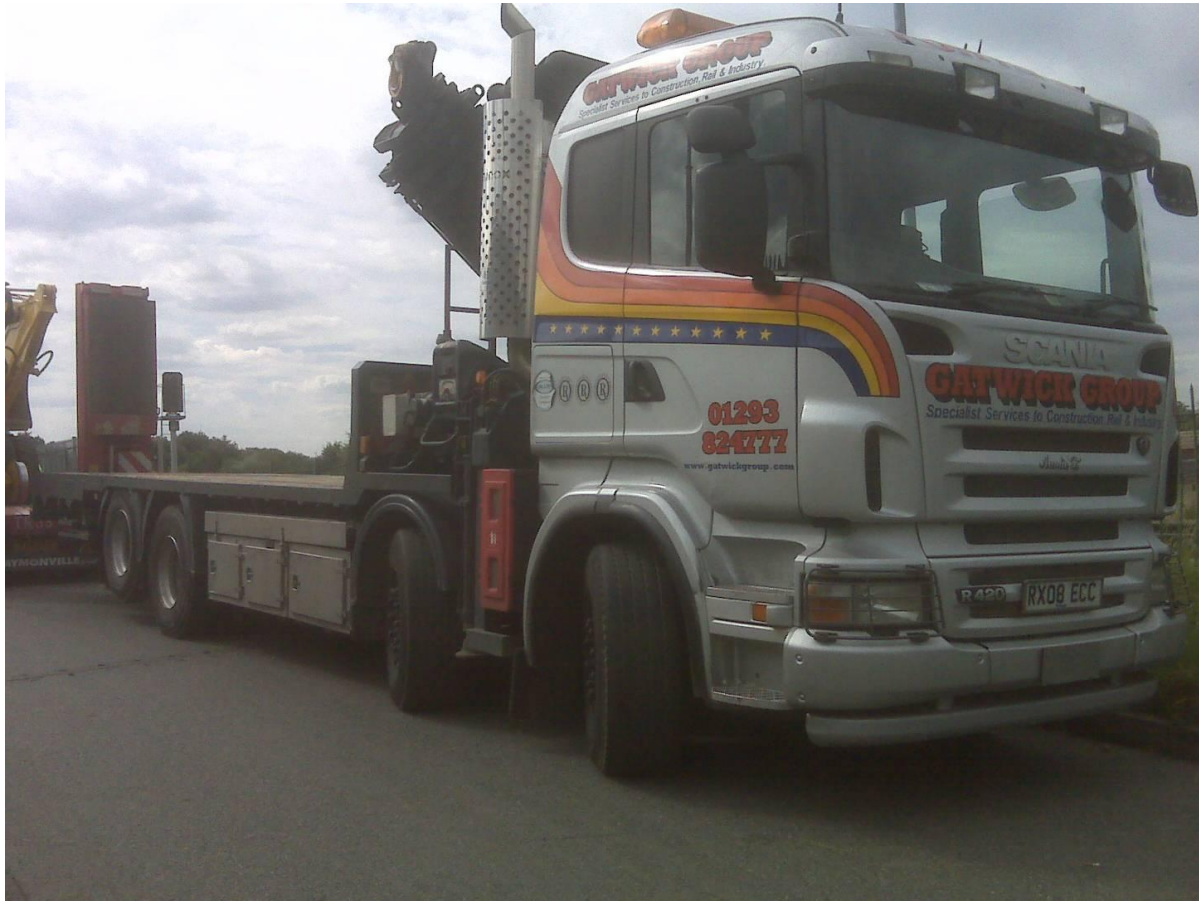
Fig 2:- Other vehicle involved in the accident

Another lorry owned by Gatwick Group, having made a delivery to Balfour Beatty, exited the depot gates and passed the Quattro lorry.
