No: IG 216

Infrastructure Group Safety Bulletin

Working adjacent to live 3rd rail

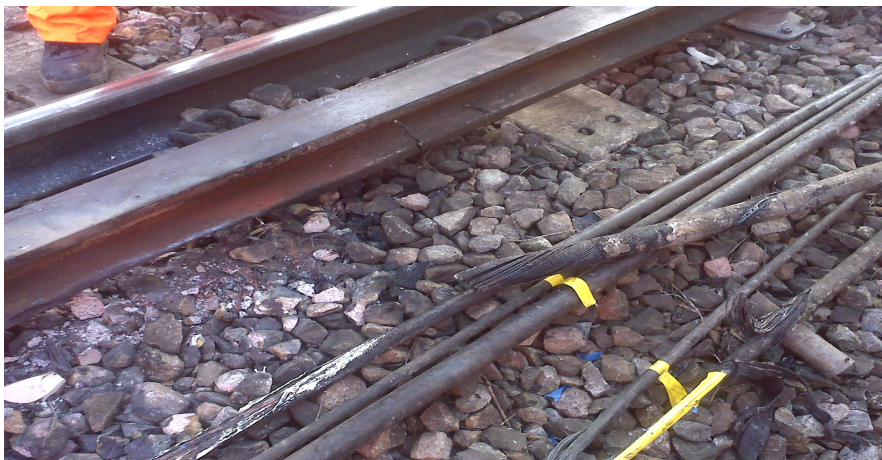
When working on lineside cables on the morning of Tuesday 17th November, a lineside cable came into contact with the live conductor rail near Sittingbourne in Kent causing damage to the signalling equipment and to the power supply. In addition to the damage, there were several hours of significant disruption to train operations in the area.

There were no staff injuries. A Network Rail formal investigation has commenced.

All staff whose duties require them to work adjacent to any live rails must understand the arrangements and controls adopted for their safety, this could take the form of a Conductor Rail Isolation Permit, approved insulated tools, protective shrouds and or rail guards. The Controller of Site Safety (COSS) should advise and brief you on these arrangements prior to you starting work.

If in any doubt, stop work and advise the COSS.

All staff are further reminded that work within 300mm of live conductor rails is only possible with a 3rd rail isolation permit or the use of approved insulated tools and equipment including protection shrouds and or guard boards.

These details are included in the rule book - GE/RT 8000/DC module DC.
